Sorrento at the Colony

Reserve Study

For Period Beginning January 1, 2025

23650 Via Veneto, Estero, FL, 34134

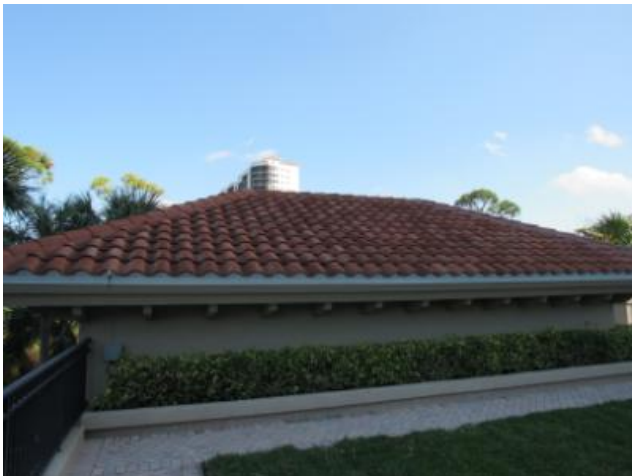
1 - Mechanical Building Roofing System

Type of Cost:	Replacement
Category:	Roofs
Location:	Roof
Regulatory:	General Reserves
Condition:	Good

The mechanical building roof is covered by a clay tile roofing system. Clay tile roofing systems, such as the one observed at the subject site, typically have a useful life of 25 years under normal operating conditions with routine yearly maintenance. We understand that the subject mechanical building roof is original to construction, circa 2001. At the time of our site visit, the mechanical building roof system was observed to be in good condition for its age. We have included a reserve item for the replacement of the subject mechanical building roofing system.

View of subject mechanical building roofing system.

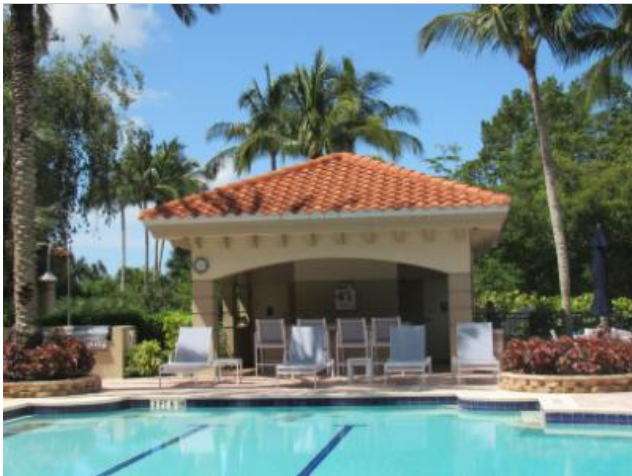
2 - Pool Pavilion Roofing System

Type of Cost:	Replacement
Category:	Roofs
Location:	Roof
Regulatory:	General Reserves
Condition:	Good

The pool pavilion roof is covered by a clay tile roofing system. Clay tile roofing systems, such as the one observed at the subject site, typically have a useful life of 25 years under normal operating conditions with routine yearly maintenance. We understand that the subject pool pavilion roof is original to construction, circa 2001. At the time of our site visit, the pool pavillion roof system was observed to be in good condition for its age. We have included a reserve item for the replacement of the subject pool pavilion roofing system.

View of subject pool pavilion clay tile roofing system.

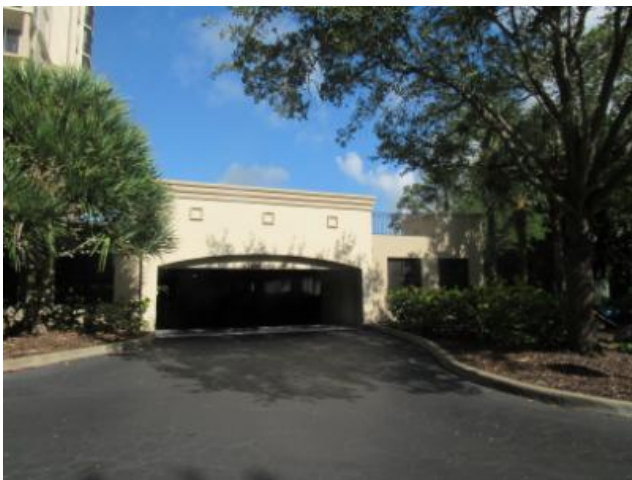
4 - Asphalt Paving Replacement

Type of Cost:	Replacement
Category:	Pavement
Location:	Property
Regulatory:	General Reserves
Condition:	Good

We understand the association is responsible for maintaining the asphaltic pavement throughout the subject condominium property. The asphaltic pavement is original to construction, circa 2001. Asphaltic pavement typically has a useful life of approximately 20 years before requiring replacement. At the time of our inspection, this item was noted to be beyond its intended useful life and showed signs of deterioration. We suggest scheduling the replacement of the subject asphaltic pavement in 2025. A reserve has been included for the replacement of the subject asphaltic pavement on a 25-year cycle, starting in 2026.

View of typical asphaltic pavement located throughout the subject property.

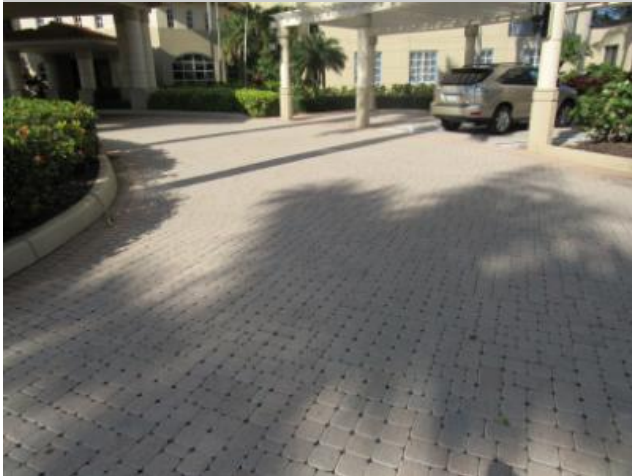
Type of Cost:	Replacement
Category:	Pavement
Location:	Property
Regulatory:	General Reserves
Condition:	Good to Fair

We understand the association is responsible for maintaining the interlocking concrete pavers located throughout the subject condominium's roadway and parking areas. The type of interlocking concrete pavers observed during our site inspection typically have a useful life of 40 years before requiring replacement. A reserve has been included for the replacement of the subject interlocking pavers, as mentioned above, on a 50-year cycle.

View of subject roadway and/or parking concrete pavers.

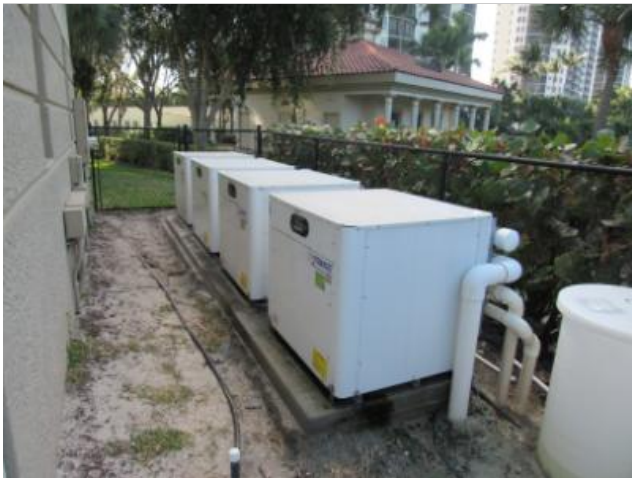
Type of Cost:	Replacement
Category:	Pool & Spa
Location:	Pool Area
Regulatory:	General Reserves
Condition:	Good

We understand the association is responsible for maintaining all pool-related equipment, including the pool heaters. The subject condominium's pool system includes (4) geothermal pool heaters. We understand that the association had each pool heater replaced as needed throughout the subject condominium's lifetime. The type of geothermal pool heaters observed typically have a useful life of 15-years before requiring major repairs/replacement. A reserve has been included for the replacement of each pool heater on a 15-year cycle.

View of subject geothermal pool heaters.

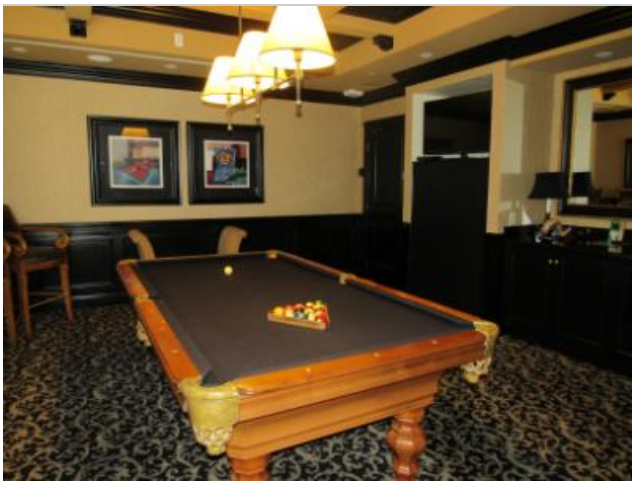
Type of Cost:	Improvement
Category:	Common Area Interiors
Location:	1st Floor Residential
Regulatory:	General Reserves
Condition:	Good

We understand the association is responsible for maintaining the common use billiard room's interior, including all finishes and furnishings. We understand the subject billiard room and associated furnishings are original to construction, circa 2001. A reserve has been included for the refurbishing of the subject billiard room on a 40-year cycle.

Overview of subject billiard room furnishings and finishes.

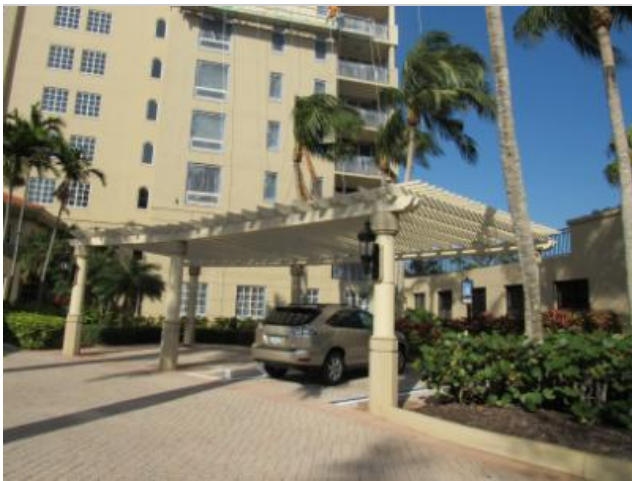
Type of Cost:	Replacement
Category:	Common Area Exteriors
Location:	Property
Regulatory:	General Reserves
Condition:	Good

We understand the association is responsible for maintaining the various wooden trellises located throughout the property. We understand the association had various repairs completed to the subject trellises in 2013. A reserve has been included for the repair and/or replacement of the subject trellises over a 25-year cycle.

View of subject wooden trellises.

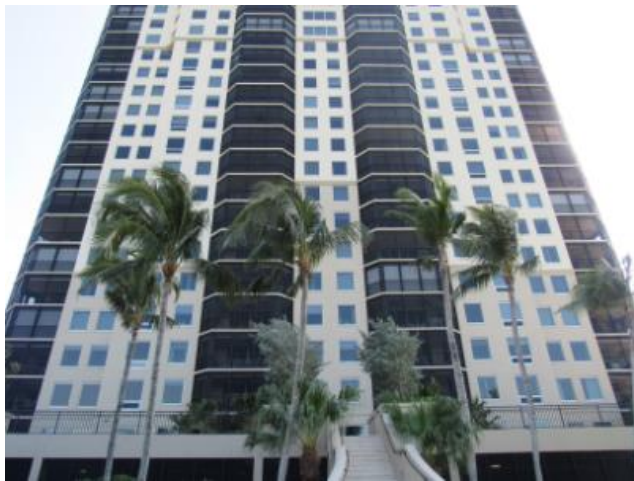
Type of Cost:	Replacement
Category:	Common Area Exteriors
Location:	Units
Regulatory:	General Reserves
Condition:	Good

We understand the association is responsible for maintaining the railings and screen enclosures associated with each individual unit balcony. We understand the association had various repairs completed to the subject individual unit balcony railings and screen enclosures in 2014. A reserve has been included for the repair and/or replacement of the subject railings and screen enclosures on a 35-year cycle.

Overview of subject unit balcony screen enclosures and railings.

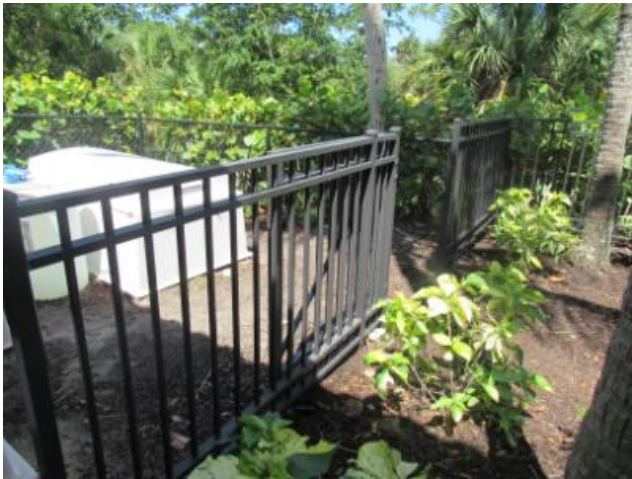
Type of Cost:	Replacement
Category:	Common Area Exteriors
Location:	Property
Regulatory:	General Reserves
Condition:	Good

We understand the association is responsible for maintaining the chain link and/or aluminum fencing located along the western end of the property, dividing the subject condominium property from the neighboring preserve area. We understand the association had the subject chain-link fence installed in 2015. A reserve has been included for repair and/or replacement of the subject chain-link fence over a 40-year cycle.

View of subject preserve fencing.
