Sorrento at the Colony

**Structural Integrity Reserve Study**

For Period Beginning January 1, 2025

23650 Via Veneto, Estero, FL, 34134

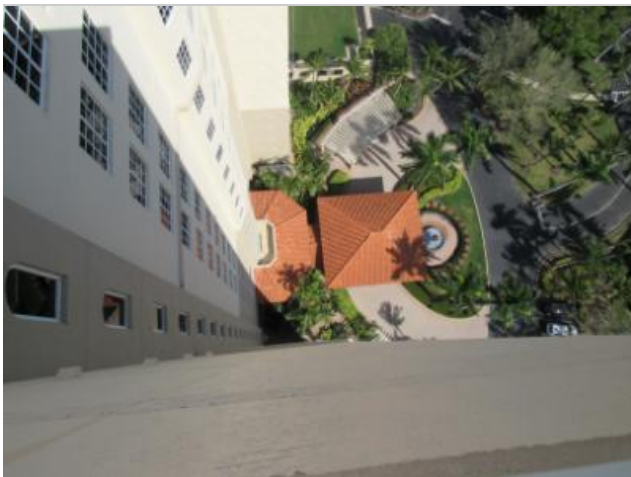
### 1 - Porte Cochere Roof - Concrete Tile

Type of Cost:	Replacement
Category:	Roofs
Location:	Roof
Regulatory:	SIRS Requirement
Condition:	Good to Fair

The porte cochere roof is covered by a concrete tile roofing system. Concrete tile roofing systems, such as the one observed at the subject site, typically have a useful life of 25 years under normal operating conditions with routine yearly maintenance. We understand the subject porte cochere roof is original to construction, circa 2001. At the time of our site visit, the porte cochere roof system was observed to be in good to fair condition for its age. We have included a reserve item for the replacement of the porte cochere roofing system.

Porte-Cochere roofing system observed during our site inspection.

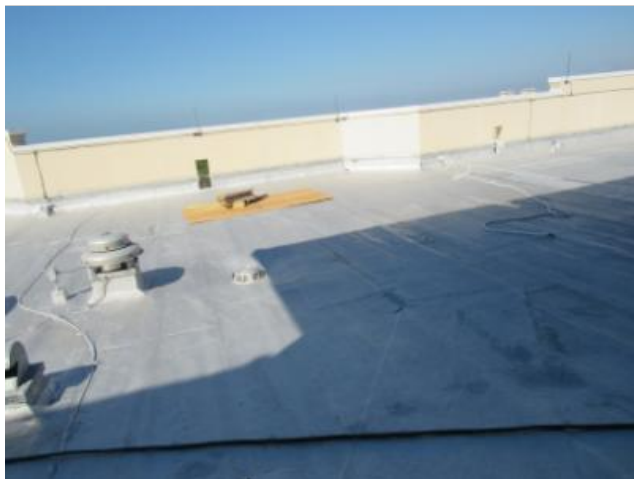
## 2 - Flat Tower Roof- Modified Bitumen (Mod-Bit)

Type of Cost:	Replacement
Category:	Roofs
Location:	Roof
Regulatory:	SIRS Requirement
Condition:	Good

The subject condominium tower's flat roof portions are covered by a Modified-Bitumen (Mod-Bit) roofing system coated with an additional elastomeric aluminum coating. Modified-Bitumen roofing systems, such as the one observed at the subject site, typically have a useful life of 25 years under normal operating conditions with routine yearly maintenance. We understand that the subject tower's flat roof portions are original to construction, circa 2001. At the time of our site visit, the subject tower's flat roof portions were observed to be in fair condition for their age. We have included a reserve item for the replacement of the subject tower's flat roofing system.

Subject tower flat roofing system observed during our site inspection.

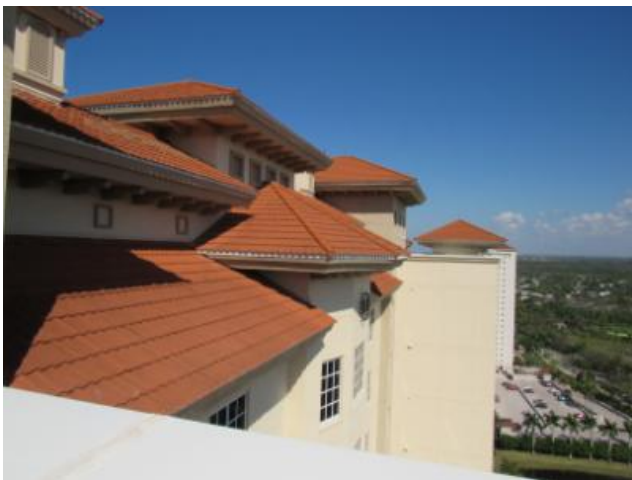
# 3 - Sloped Tower Roof - Stone Coated Metal

Type of Cost:	Replacement
Category:	Roofs
Location:	Roof
Regulatory:	SIRS Requirement
Condition:	Good

The subject condominium tower's sloped roof portions are covered by a stone-coated metal tile roofing system. Stone-coated metal tile roofing systems, such as the one observed at the subject site, typically have a useful life of 40 years under normal operating conditions with routine yearly maintenance. We understand that the subject tower's sloped roof portions are original to construction, circa 2001. At the time of our site visit, the subject tower's sloped roof portions were observed to be in good condition for their age. We have included a reserve item for the replacement of the subject tower's sloped roofing system.

Subject tower sloped roofing system observed during our site inspection.

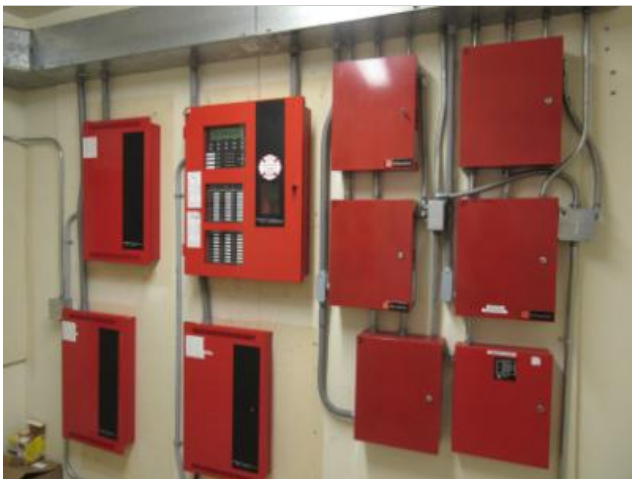
# 5 - Fire Alarm System Modernization

Type of Cost:	Replacement
Category:	Fireproofing & Fire Protection Systems
Location:	Mechanical Room
Regulatory:	SIRS Requirement
Condition:	Good

The main fire alarm control panel (FACP), for the subject condominium, is located within the first floor Fire Command Room. Additionally, fire extinguishers, audio/visual alarms, and other fire alarm system equipment are located throughout the subject condominium. Typically, these systems have a useful life of 25 years before requiring updating. When replacing a fire control panel, typically an update to other various control boxes and audio/visual alarms are required. We understand that the fire alarm system components were last replaced and/or updated in 2020. Therefore, a reserve has been included for replacement/modernization of the FACP and other related fire alarm system components.

Typical Fire Alarm System components observed during our site inspection.

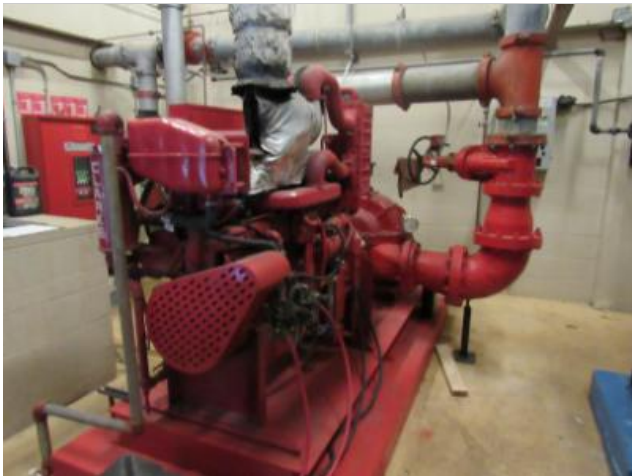
# 6 - Fire Pump/Equipment

Type of Cost:	Replacement
Category:	Fireproofing & Fire Protection Systems
Location:	Mechanical Room
Regulatory:	SIRS Requirement
Condition:	Good

The fire pump, fire pump controller, diesel fuel tank and other related equipment are located within the ground floor Mechanical Room along the Northern end of the property. Typically, these systems have a useful life of 45 years before requiring major system updates and/or replacement. We understand the fire pump and its related equipment are original to construction of the condominium, circa 2001. Therefore, a reserve has been included for major upgrades and/or replacement of the fire pump equipment on a 45-year cycle.

Typical Fire Pump and related equipment observed during our site inspection.

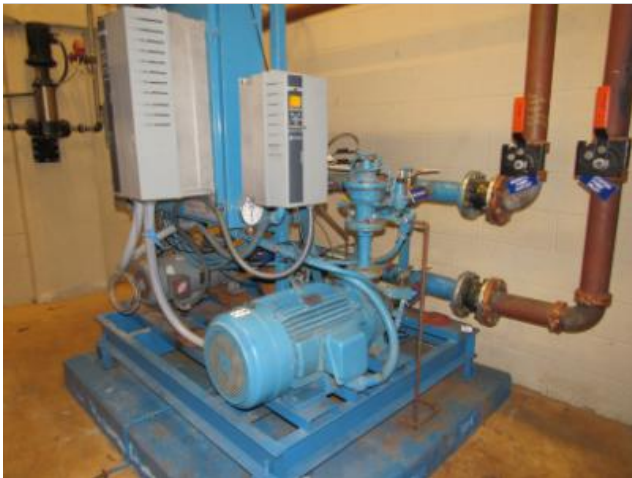
# 7 - Domestic Water Pumps/Equipment

Type of Cost:	Replacement
Category:	Plumbing
Location:	Entire Building
Regulatory:	SIRS Requirement
Condition:	Good

The subject condominium includes (1) 30 horsepower and (1) 15 horsepower domestic water pumps. The domestic water pumps, pump controller, and other related equipment are located within the ground floor Mechanical Room along the Northern end of the property. Typically, these types of domestic water pump systems have a useful life of 25 years before requiring major repairs and/or replacement. We understand the domestic water pumps were last replaced in 2015. Therefore, a reserve has been included for repair/replacement of the domestic water pumps and their related equipment.

Typical Domestic Water Pump and related equipment observed during our site inspection.

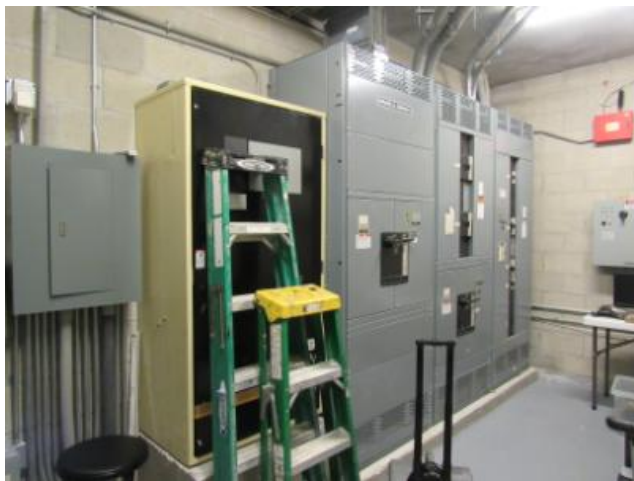
# 9 - Electrical System

Type of Cost:	Repairs & Maintenance
Category:	Electrical
Location:	Mechanical Room
Regulatory:	SIRS Requirement
Condition:	Good

Currently there are no indications of any deterioration or issues with the common area electrical system for the subject condominium. The main disconnects and breakers are located within the electrical room on the first floor of the building. Localized breaker panels and branch circuits are typically replaced during common area or individual unit renovations as required to accommodate the renovation. Therefore, a reserve has been included for partial periodic replacement/upgrades of major electrical system components such as main service panels and breakers.

Typical electrical system components observed during our site inspection.

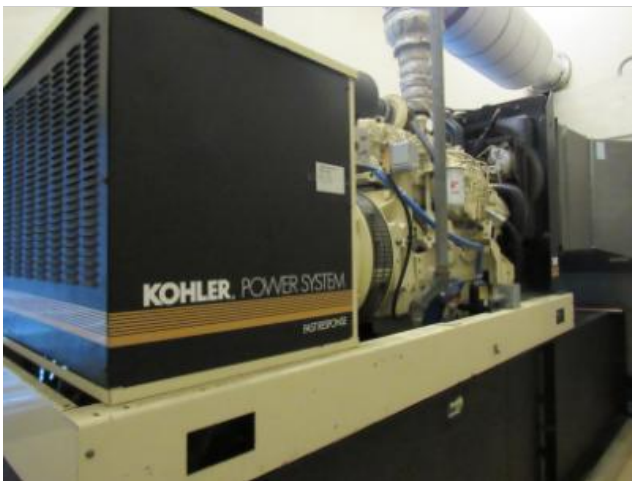
# 10 - Generator with Transfer Switch

Type of Cost:	Replacement
Category:	Electrical
Location:	Mechanical Room
Regulatory:	SIRS Requirement
Condition:	Good

The subject condominium includes a 200kW emergency diesel generator by Kohler. The emergency generator, transfer switch, and other related equipment are located within the ground floor Generator Room located along the Northern end of the property. Typically, these types of generators have a useful life of 40 years before requiring major repairs and/or replacement. We understand the subject emergency generator and equipment are original to construction, circa 2001. Therefore, we have included a reserve to address major repairs and/or replacement of the emergency generator system.

200 kW generator observed during our site inspection.

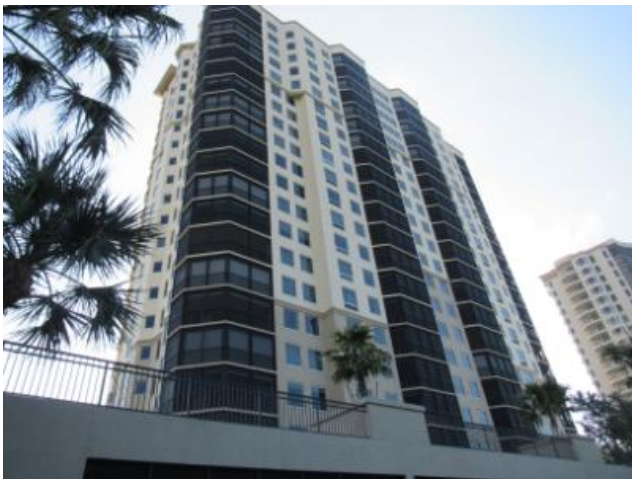
# 11 - Building Exterior Paint & Seal

Type of Cost:	Replacement
Category:	Exterior Painting & Waterproofing
Location:	Entire Building
Regulatory:	SIRS Requirement
Condition:	Good

We understand the subject building's exterior surfaces were last recoated and re-sealed in 2024. For buildings located in the Southwest Florida region, we typically recommend the exteriors be recoated 5 years after initial construction and then on a 7-year basis, this is of course dependent on the quality of workmanship and overall product utilized. Therefore, a reserve has been included for periodic recoating and re-sealing of the building's exterior on a 7-year paint cycle.

Overview of subject building exterior observed during our site inspection.

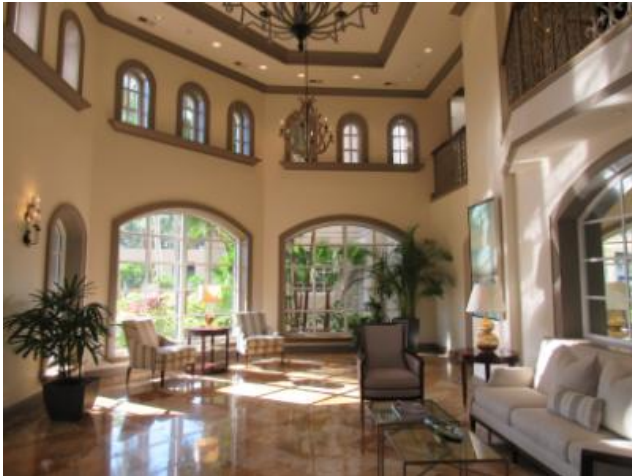
# 15 - Lobby, Social Room, Guest Suites, Manager's Suite - Windows & Doors

Type of Cost:	Replacement
Category:	Windows & Doors
Location:	Ground & Lobby Levels
Regulatory:	SIRS Requirement
Condition:	Good

We understand that all ground floor/lobby windows and doors are the responsibility of the association. Typically, these types of windows and doors have a useful life of 40+ years. We understand that all ground floor/lobby windows and doors are original to construction, circa 2001. Therefore, we have included a reserve for the replacement of the ground floor/lobby windows and doors.

Typical ground floor and/or lobby windows observed during our site inspection.
